WOODBURY CREEK DAM

NJ 00398

**PHASE 1 INSPECTION REPORT
NATIONAL DAM SAFETY PROGRAM**

February, 1979

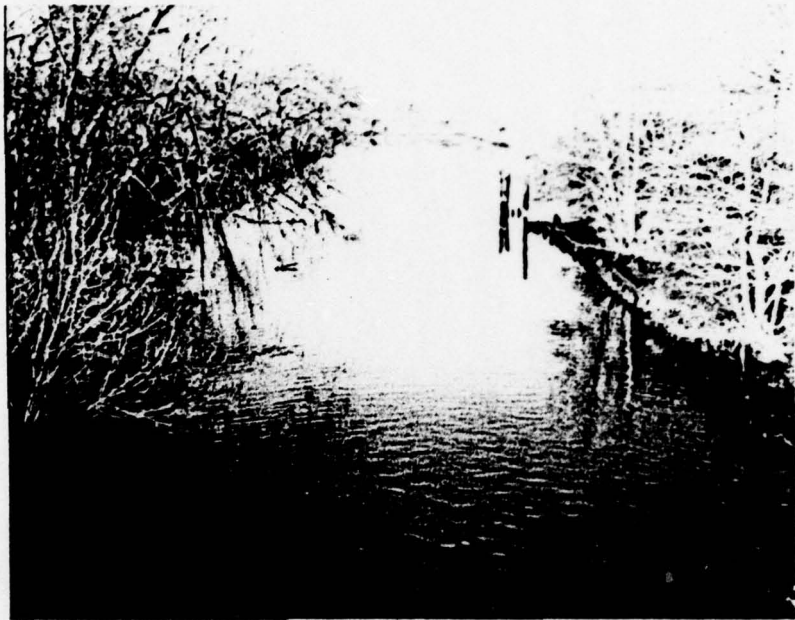
View of downstream channel from highway bridge

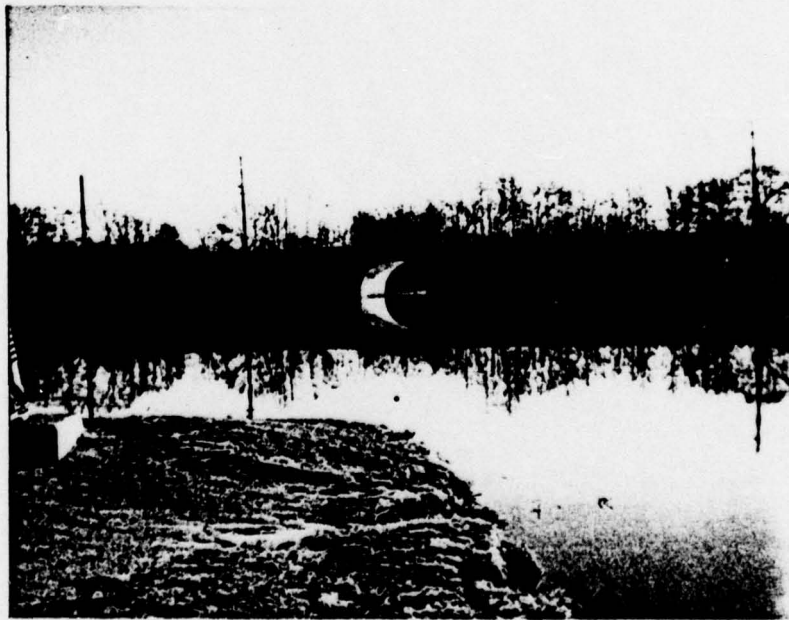
View East of Broad St. Lake and railroad bridge

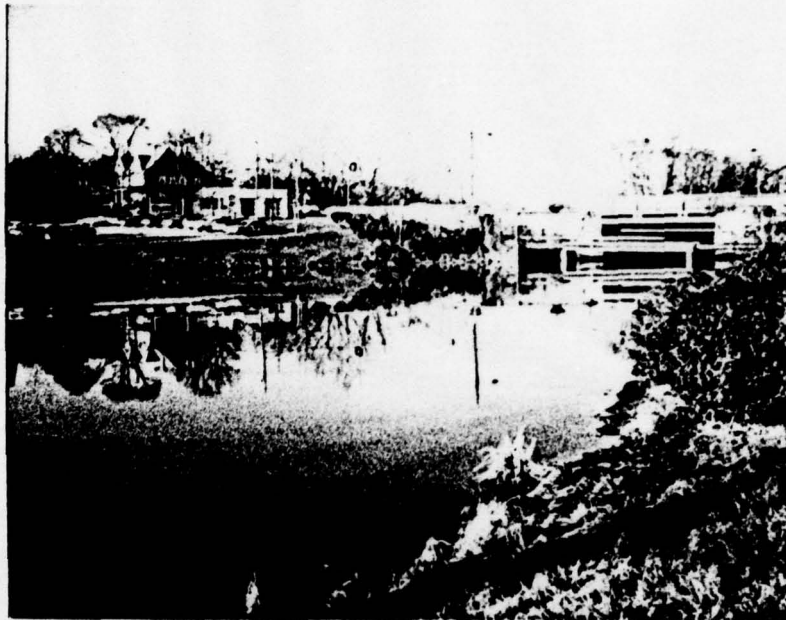
View West of Broad St. Lake and dam

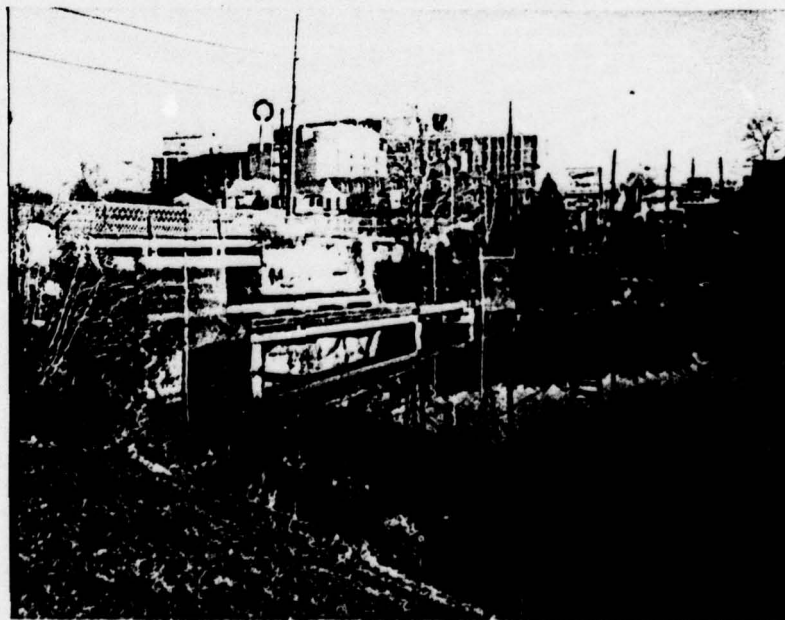
Water/Sewer lines across bridge opening

It is suggested that in the future, the owner review the possibility of relocating the utility lines that parallel the east, upstream fascia of the bridge. Also, the rubble masonry retaining walls beyond the bridge wings will require extensive repairs in the future.

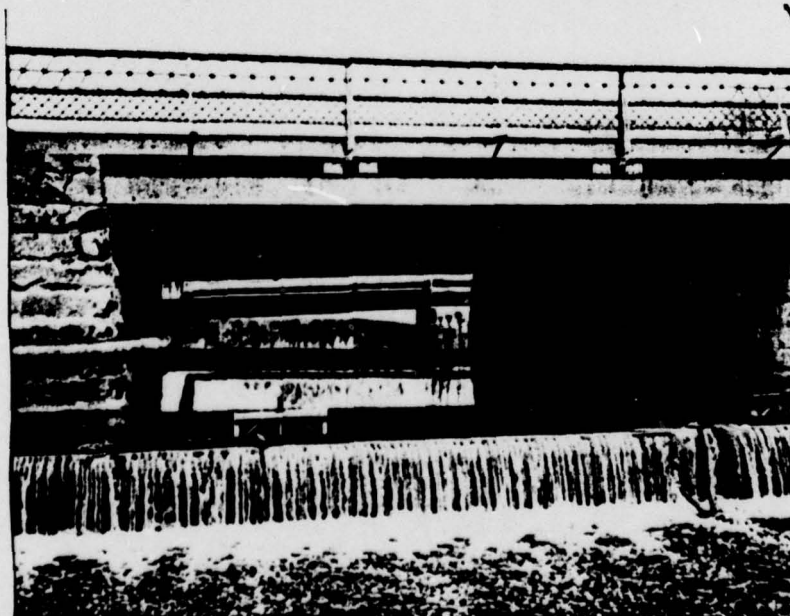
View upstream through bridge opening
